VALVE SPOOL STICKING

CUTAWAY VIEW OF A COMMERCIAL A20 VALVE SECTION

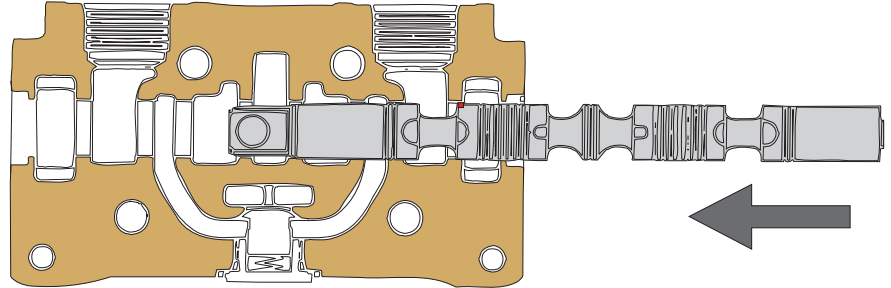
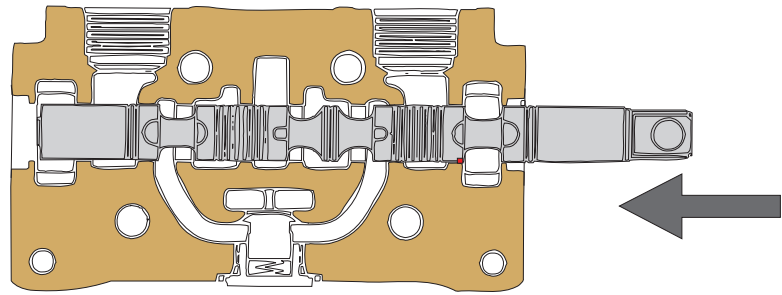
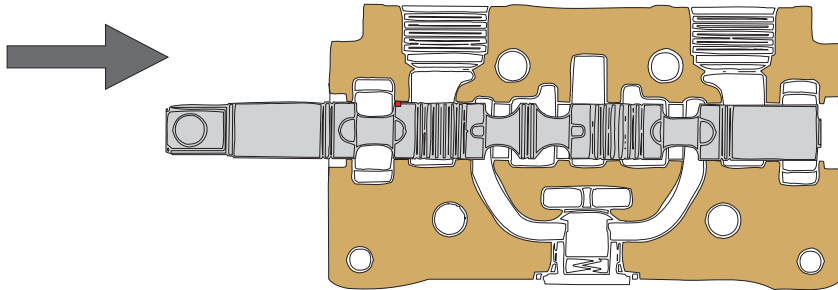
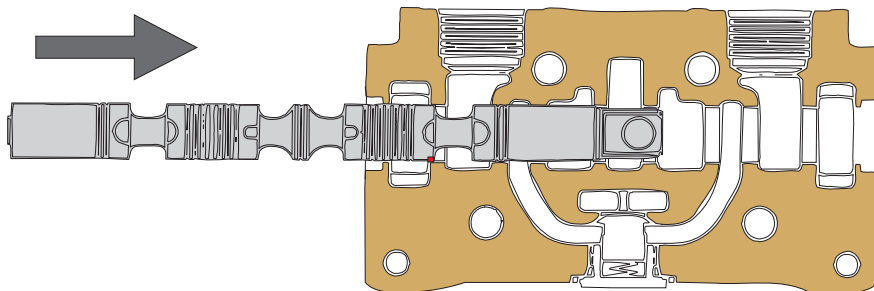
IF A BURR IS ON THE SPOOL HERE, YOU WILL BE ABLE TO INSERT SPOOL AS SHOWN BELOW

OCCASIONALLY A VALVE SPOOL WILL DEVELOP A STICKING PROBLEM THAT IS NOTICEABLE IN ONE SMALL AREA OF THE SPOOL BORE. THIS IS EVIDENT BY REMOVING THE SPOOL AND SLIDING IN FROM BOTH DIRECTIONS AND WITH BOTH ENDS AS ILLUSTRATED ON THE FOLLOWING PAGES. THE SPOOL STICKING IS CAUSED BY A VERY SMALL BURR EITHER IN THE HOUSING BORE OR ON THE EDGE OF A SPOOL LAND. THE BURR IS USUALLY SO TINY IT CANNOT BE SEEN. CAREFUL LOGICAL THINKING OF INSERTING THE SPOOL INTO THE BORE CAN DETERMINE IF THE BURR IS IN THE BORE OR ON THE LAND. WHEN THE BURR IS FOUND, IT CAN BE REMOVED WITH A STONE OR MICRO FILE.

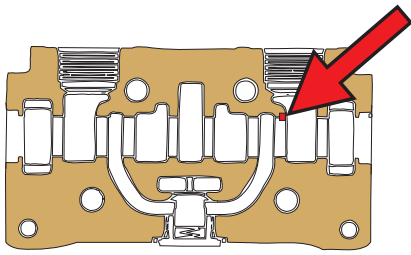
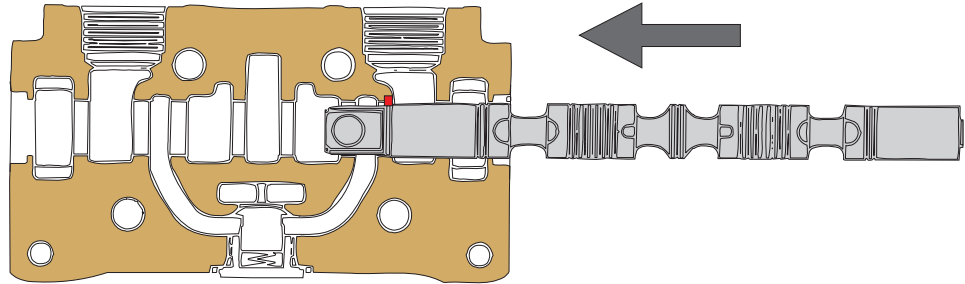
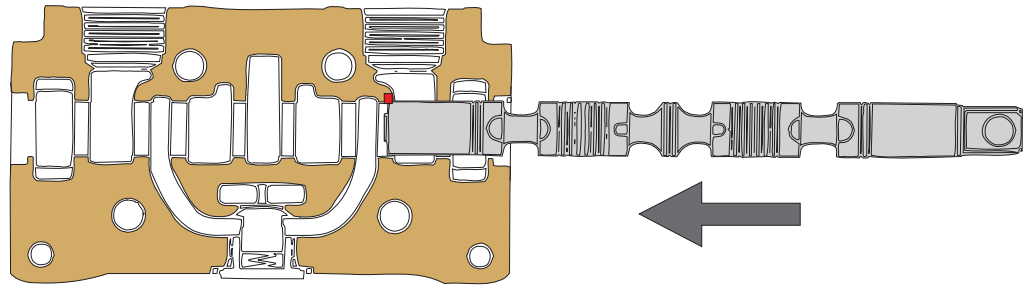
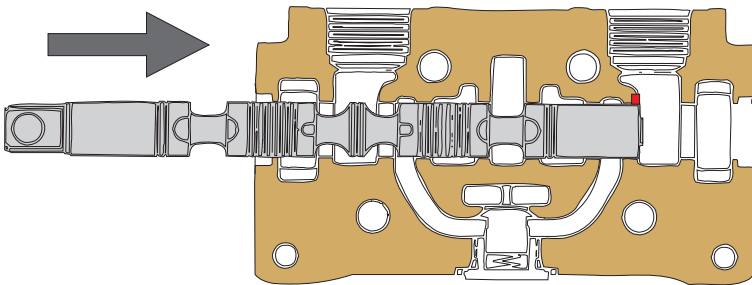
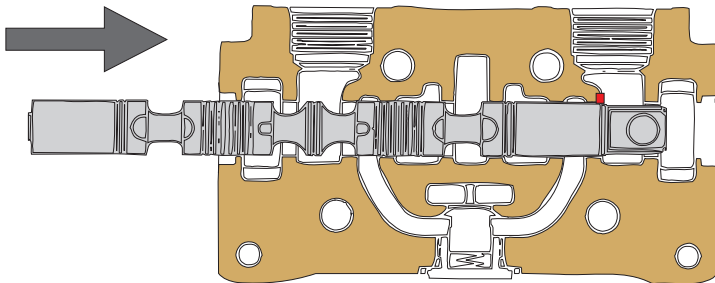
IF A BURR IS IN THE BORE HERE, YOU WILL BE ABLE TO INSERT SPOOL AS SHOWN BELOW

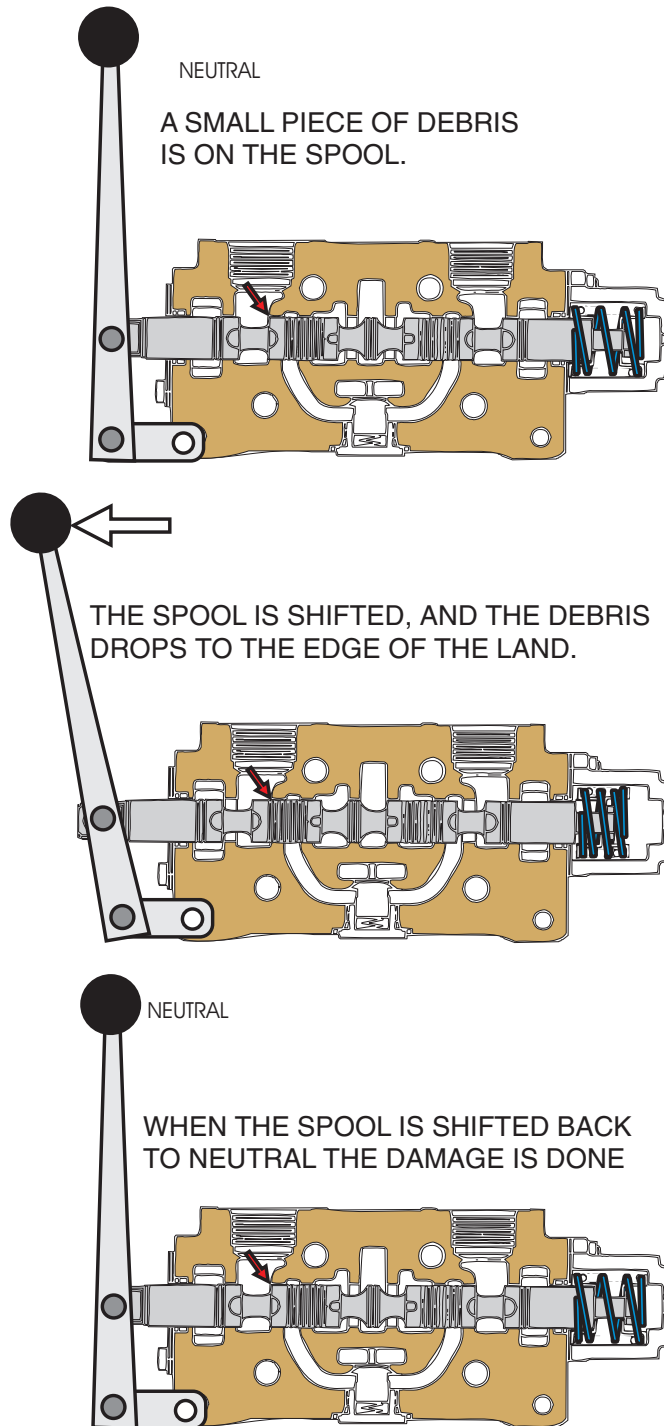
WHAT CAUSES THE BURR?

THE DAMAGE CAN ALSO BE DONE WHEN OIL IS FLOWING. AFTER THE SPOOL IS SHIFTED AND IS RETURNING TO NEUTRAL, THE OIL IS SQUEEZED IN A SMALLER AREA BY THE METERING GROOVES. IF THERE IS A PIECE OF DEBRIS IN THE FLOW WHEN IT IS SQUEEZED THROUGH THE SMALLEST OF METERING ACTION JUST BEFORE SHUTOFF, DAMAGE CAN BE DONE TO THE BORE OR SPOOL BY THE DEBRIS.
