VALVE SPOOL STICKING

CUTAWAY VIEW OF A COMMERCIAL A20 VALVE SECTION

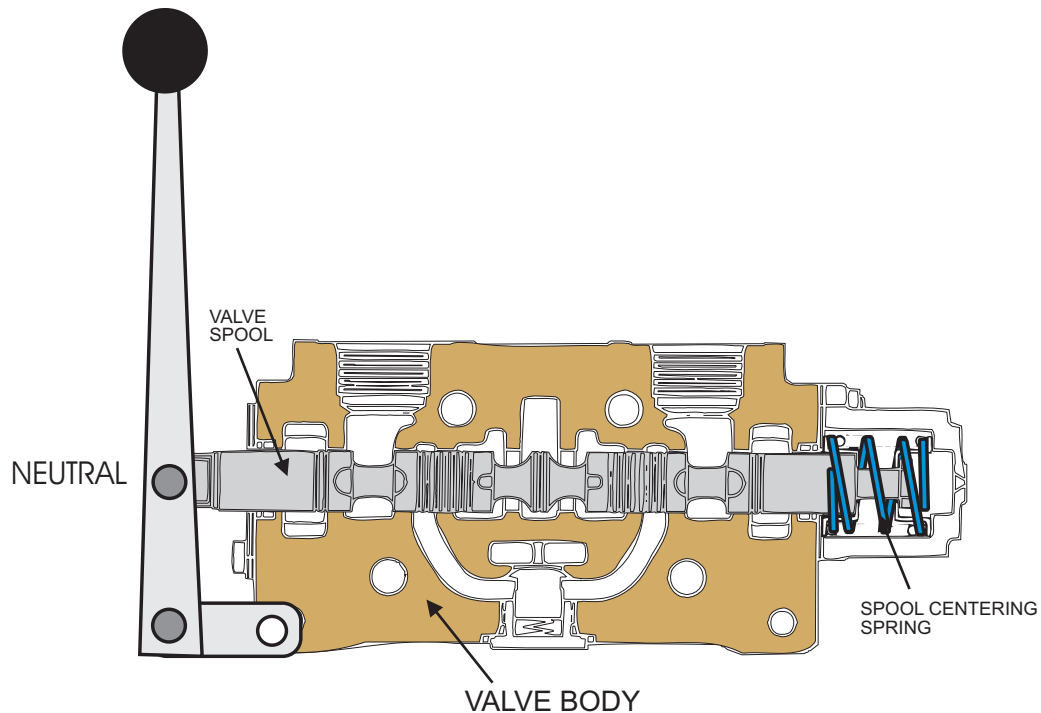
OCCASIONALLY A VALVE SPOOL WILL DEVELOP A STICKING PROBLEM THAT IS NOTICEABLE IN ONE SMALL AREA OF THE SPOOL BORE. THIS IS EVIDENT BY REMOVING THE SPOOL AND SLIDING IN FROM BOTH DIRECTIONS AND WITH BOTH ENDS AS ILLUSTRATED ON THE FOLLOWING PAGES. THE SPOOL STICKING IS CAUSED BY A VERY SMALL BURR EITHER IN THE HOUSING BORE OR ON THE EDGE OF A SPOOL LAND. THE BURR IS USUALLY SO TINY IT CANNOT BE SEEN. CAREFUL LOGICAL THINKING OF INSERTING THE SPOOL INTO THE BORE CAN DETERMINE IF THE BURR IS IN THE BORE OR ON THE LAND. WHEN THE BURR IS FOUND, IT CAN BE REMOVED WITH A STONE OR MICRO FILE.
